# RICS Home Survey Level 3

HOME SURVEY TEST - Level 3 -  
Survey, Portsmouth, Hampshire,  
PO1 1JJ

June 19th 2021

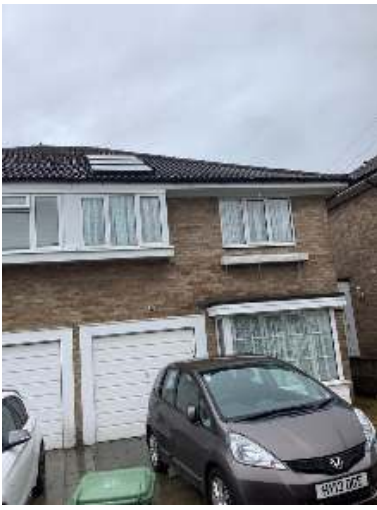
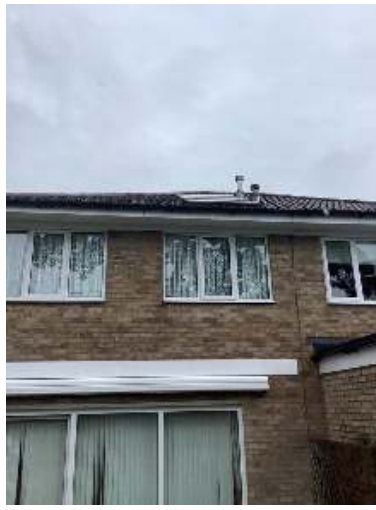
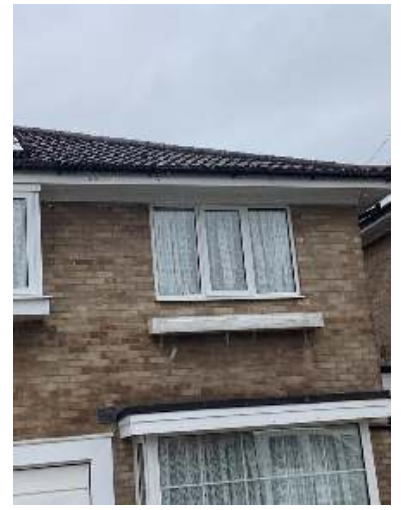
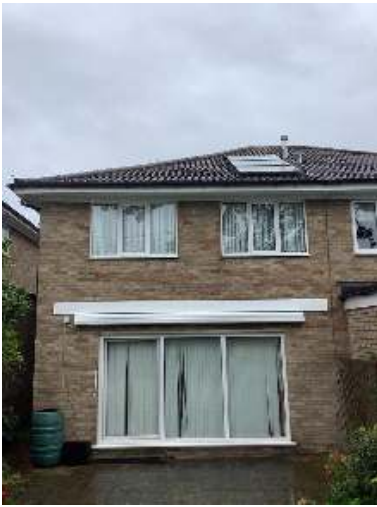
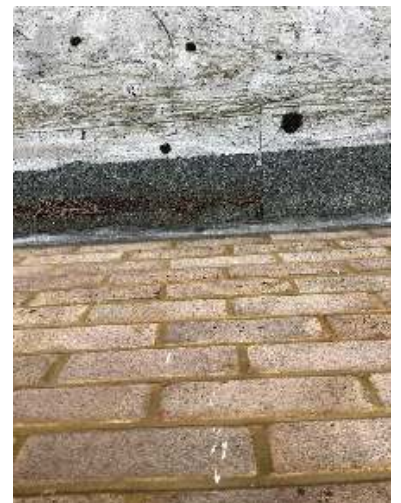
There is a significant build-up of moss on the rear elevation main roof. This will require cleaning as moss build up on the roof can block the gutters if it falls into it which can further lead to damp to form on the main walls, as well as, reducing the life expectancy of roof coverings.

I also noted visible signs of lichen growth on the hip and tiles, this will also require cleaning. Please note lichens or algae could potentially cause damage in the winter months due to frost. The moisture during the winter months could potentially cause damage to the surface during a frost/ thaw cycle. However, normally this occurs over a very long period of time, I recommend a reputable Roofing contractor to inspect and advise further.

Specialists can assess your roof's condition and the extent of the moss problem, and take action accordingly. Often a thorough clean is all that's needed. Hiring a skilled and experienced roofing professional to remove the moss will minimise the risk of damaging your roof during removal.

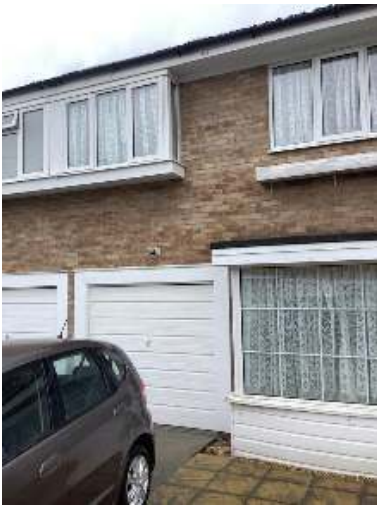
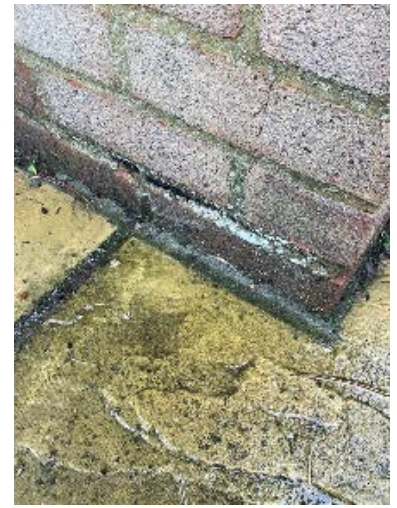
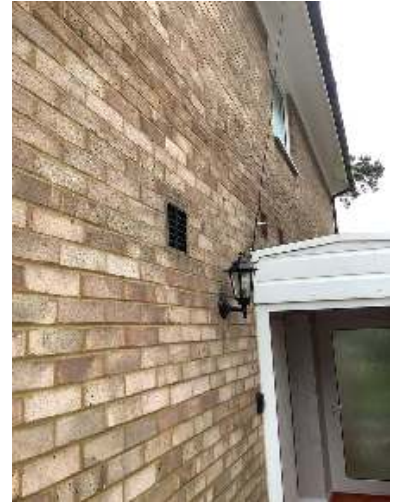
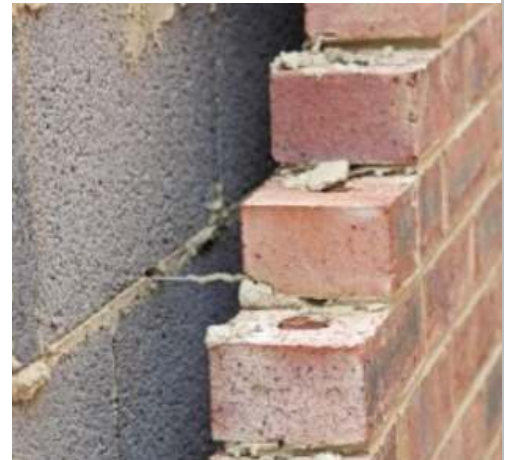
Insulation has been injected to all external walls. Some insulation material can cause corrosion of wall ties as well as passing damp from outer leaf to inner leaf of a cavity.

Brickwork and pointing appeared in satisfactory with no significant defects noted. All pointing should be checked closely and patch pointing to affected areas carried out as required. There where areas of deteriorated pointing at low level. Patch pointing is recommended.

The low level air bricks are to the side elevation and to the rear. Air bricks are used to ventilate the subfloor void which holds host to the suspended timber flooring inside the property. These should ideally be kept clear and 150mm away from the ground. This height can be estimated at two or three bricks. This is not the case with the subject property, meaning they are prone to damp in areas. If water is allowed to enter the subfloor void, then the condition of the internal floor timbers should be brought to question. I would recommend further investigation into the condition of the subfloor void and recommend lowering the ground externally.

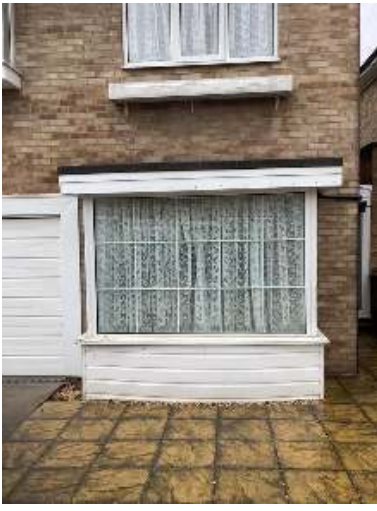
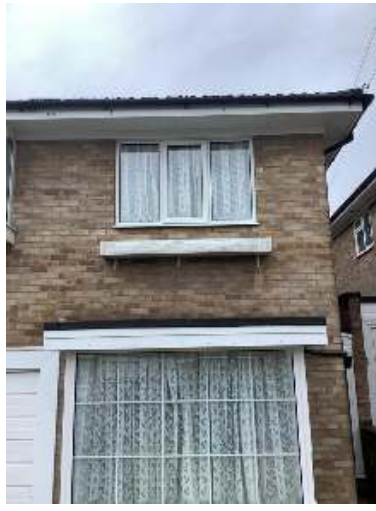
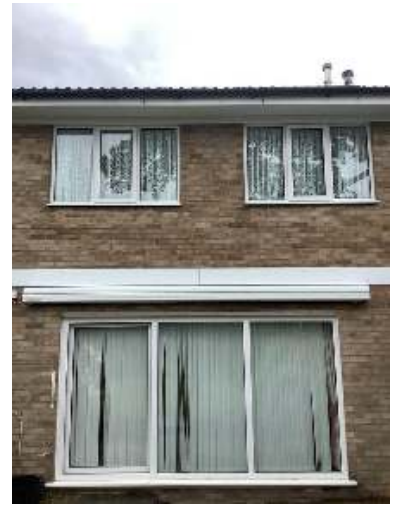
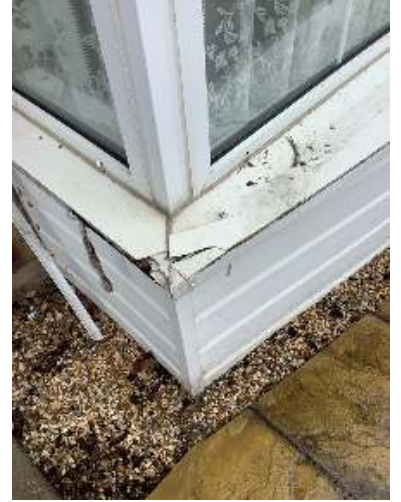
As mentioned earlier, the windows to the first floor bedrooms do not provide adequate means of escape and is therefore a health and safety hazard.

All first floor bedroom windows are not compliant with means of escape, we recommend these windows be replaced in the near future.

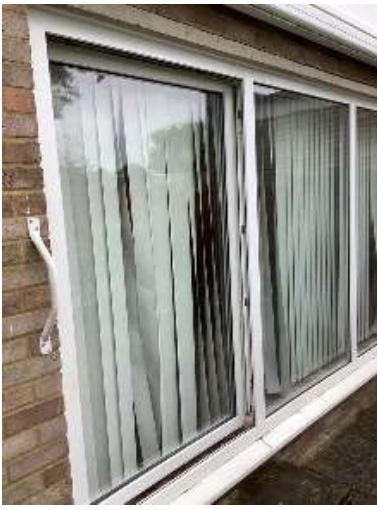
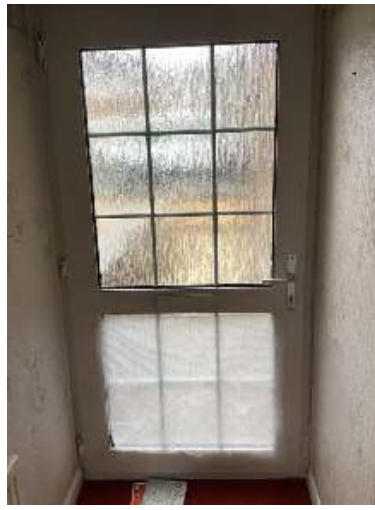
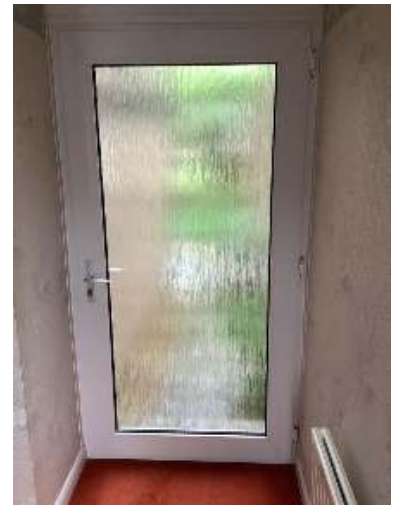
There are sealed glazed units set within the doors. Glazing in doors which is wholly or partially within 1500mm from floor level should be: Minimum Class C to BS 6206 and kite marked according to BS 6206. Glazing to the front and rear doors appeared toughened, however, there were no apparent markings to the glass. Markings may just be concealed within the framing, however, for full reassurance further investigations are recommended. If the glazing turns out not to be toughened, this will present a hazard to occupants.

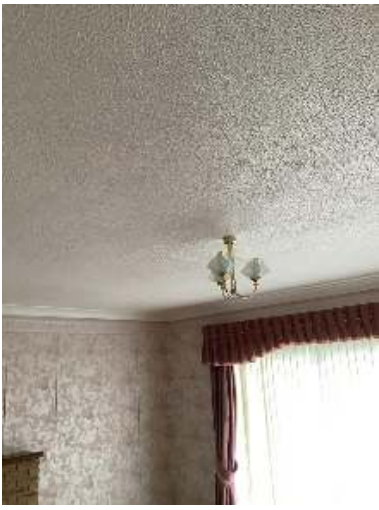
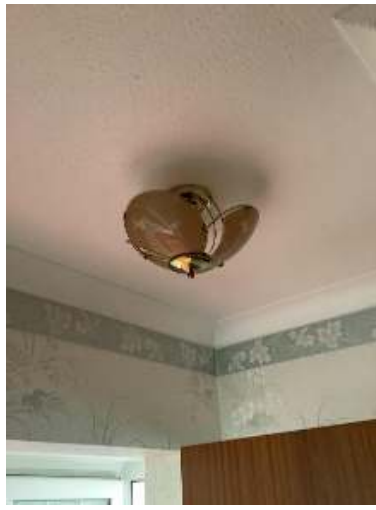
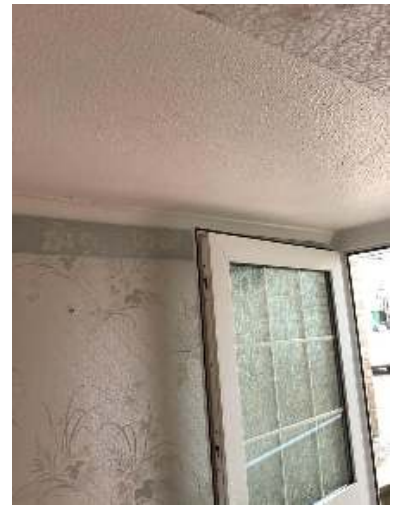
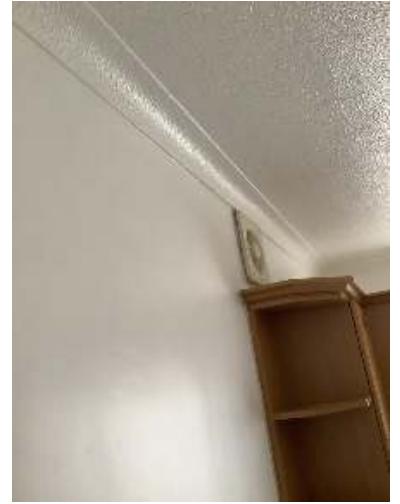
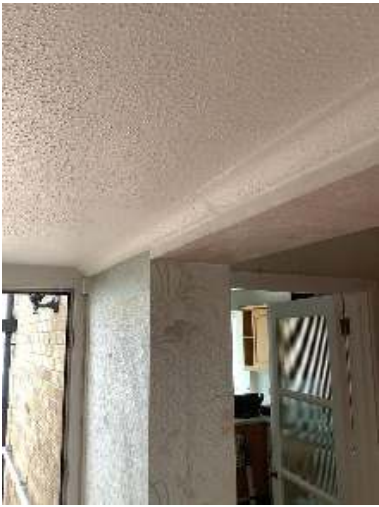
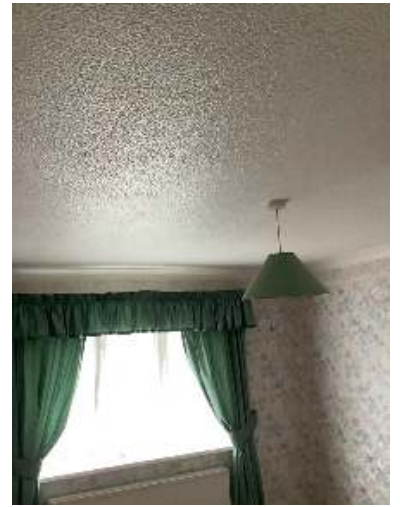
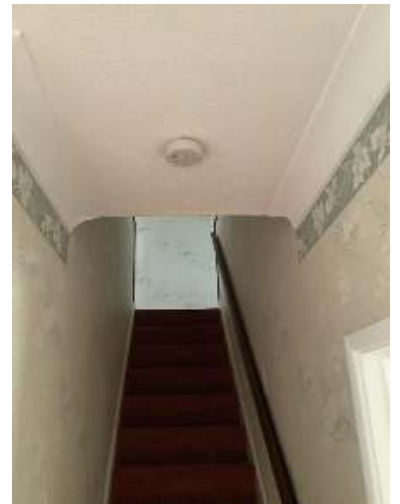
Textured coatings were observed to ceilings. The below is provided for information should these ceilings be disturbed.

The property has two battery powered smoke alarms fitted to the main entrance ceiling and landing ceiling the cover to the smoke alarm on the landing is missing. These were not tested.

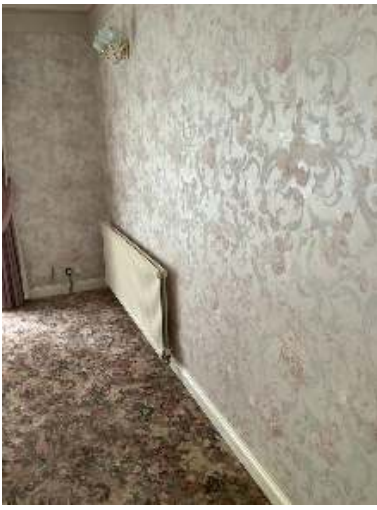
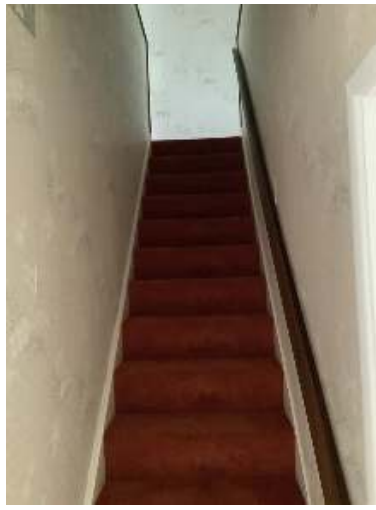
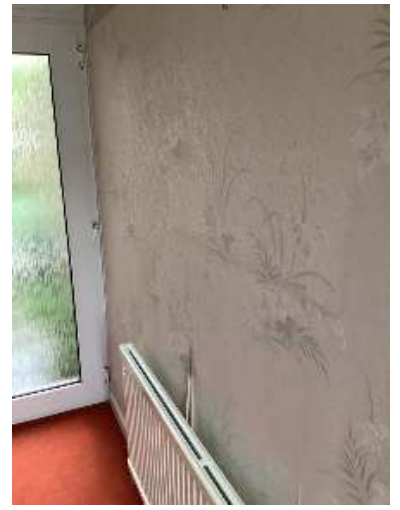
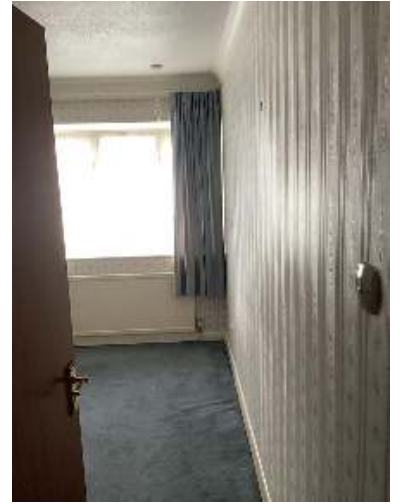
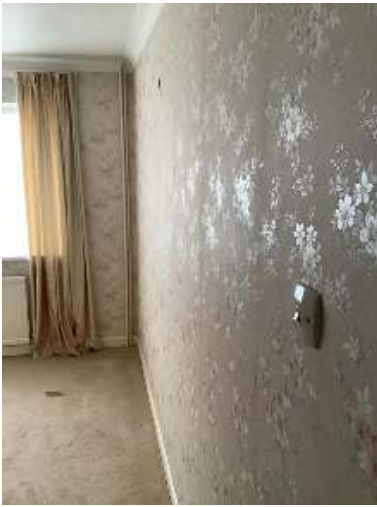
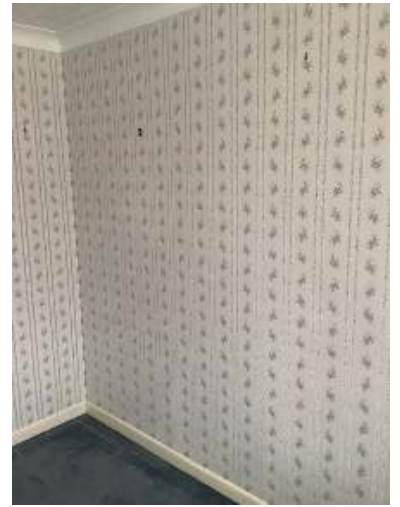
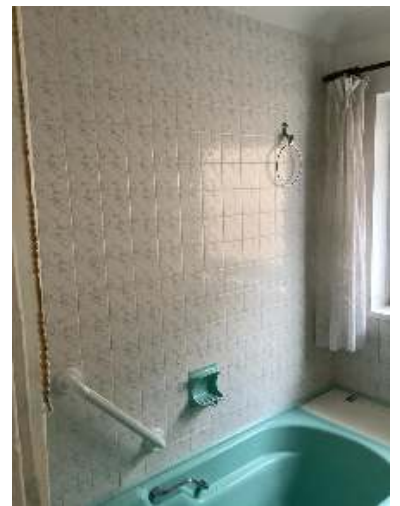
All internal solid walls do not line up on the first floor, this could mean walls are not supported. Further investigation is required.

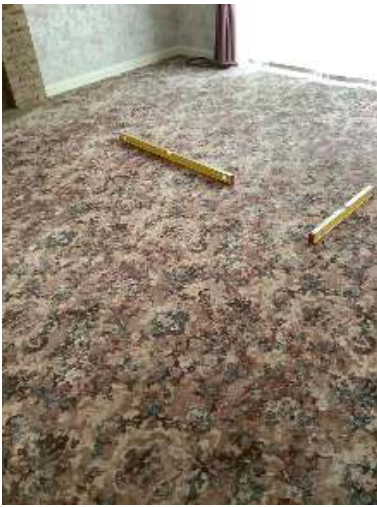
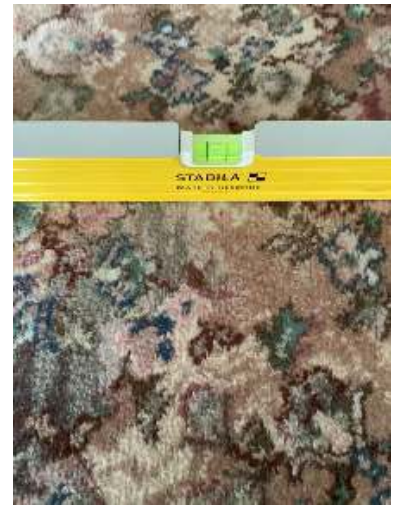
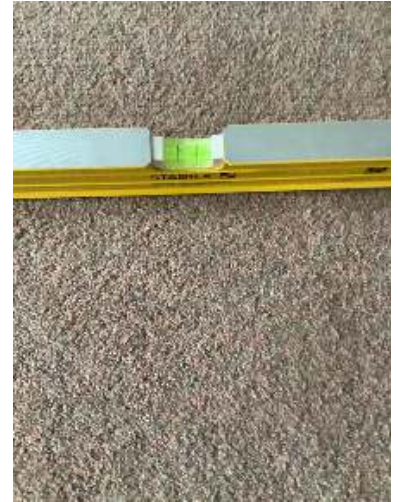
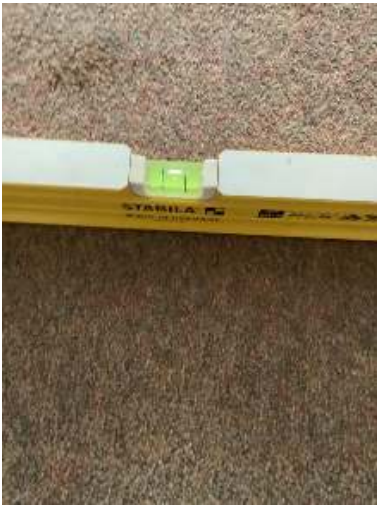
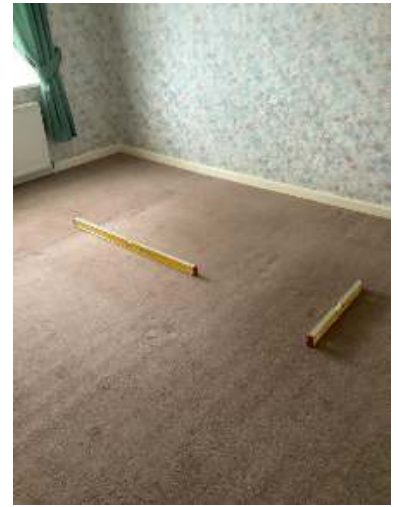
Owing to the conditions of the survey, no fixed coverings or floorboards were lifted which meant that no inspection of the subfloor timbers was possible.

Ground floor and first floor to the property appear to be of suspended timber construction.

All finished floors to property have been carpeted though out all carpet appeared in condition though dated.

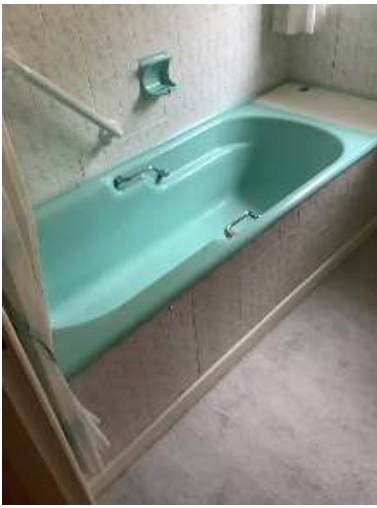
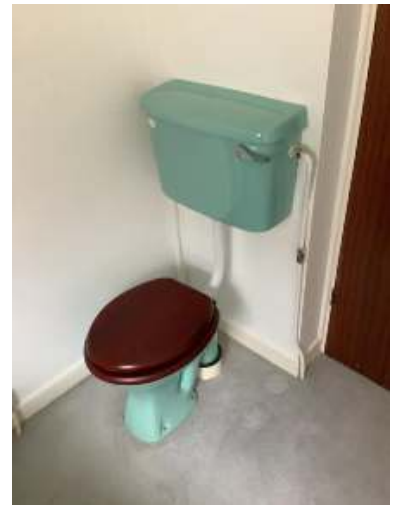
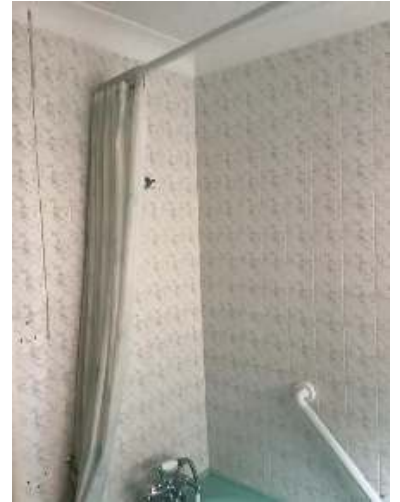
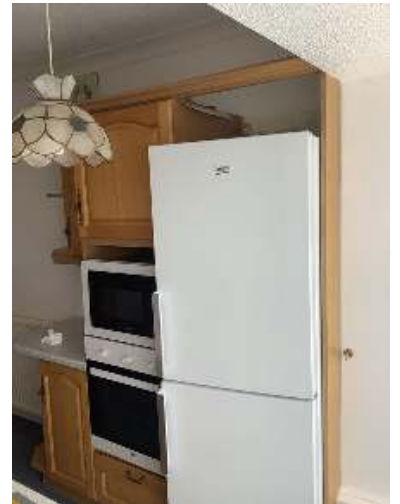
There is also a shower attachment to the bath tap, and shower curtain the main bathroom does not feature mechanical extraction. I recommend mechanical extraction is fitted soon.
