# RICS Home Survey Level 3

HOME SURVEY TEST - Level 3 -  
Survey, Portsmouth, Hampshire,  
PO1 1JJ

June 19th 2021

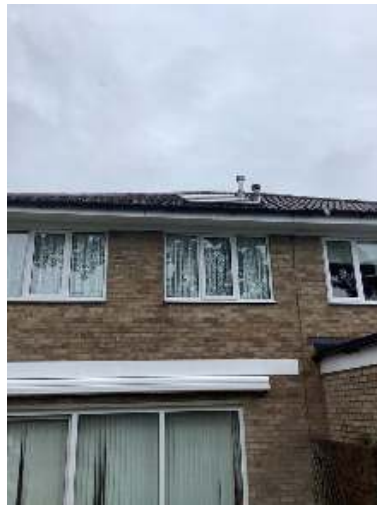
The main roof coverings to the property are a concrete interlocking roof tile with concrete ridge and hip tiles. The main roof elevations have no notable signs of sagging and the ridge and hip lines were straight within tolerance.

There is a significant build-up of moss on the rear elevation main roof. This will require cleaning as moss build up on the roof can block the gutters if it falls into it which can further lead to damp to form on the main walls, as well as, reducing the life expectancy of roof coverings.

However you decide to tackle the moss on your roof, be wary of the dangers of working on your roof. If in doubt, it's always best to hire the services of a professional roofing company who can carry out the job safely and thoroughly.

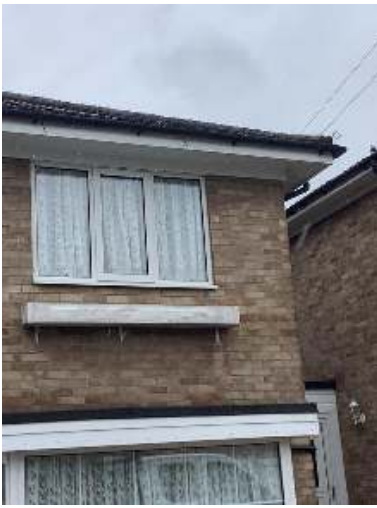
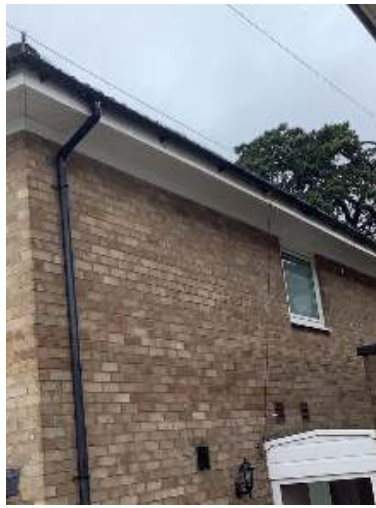
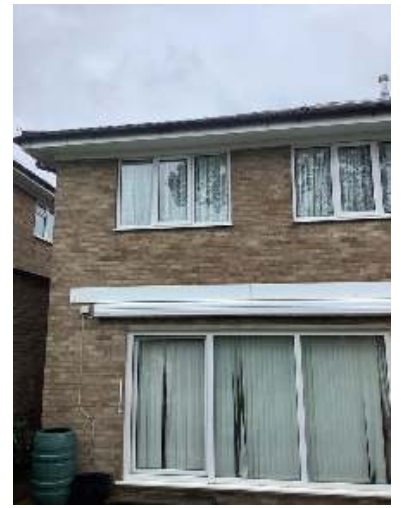
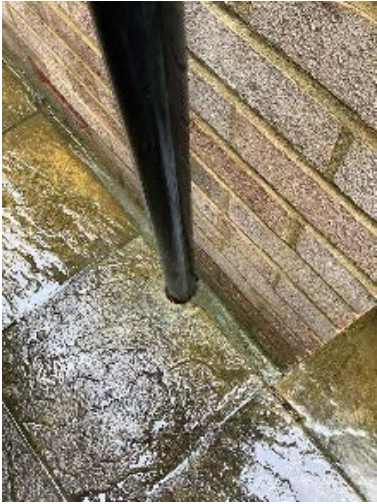
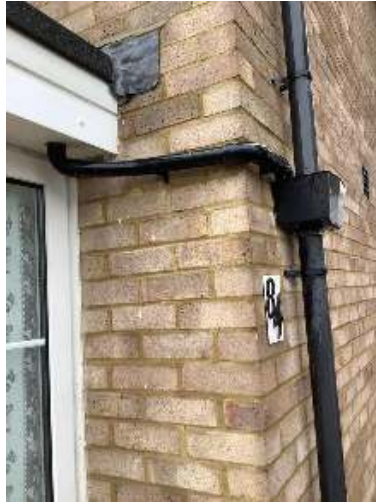
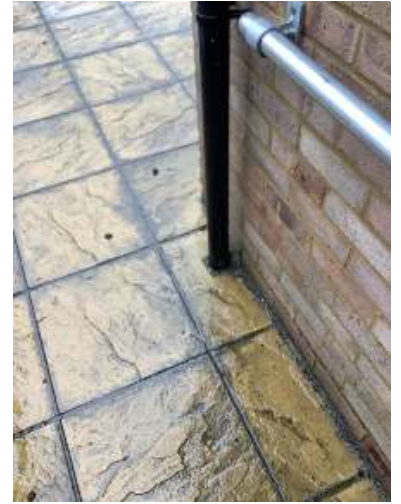
The main walls to the property have been formed with a conventional cavity wall construction. The thickness of the walls are approximately 280 mm.

The main walls to the property have been finished with a facing brick and mortar, in a common bond. All walls were upright and straight within acceptable tolerance for a property of this age and type.

A bay structure also imposes some loading on the window frames and is vulnerable to cracking and movement. This type of structure by design can develop defects in the future. If the window is changed then you have to ensure that the window has reinforcing bars, and is specifically designed for the purpose.

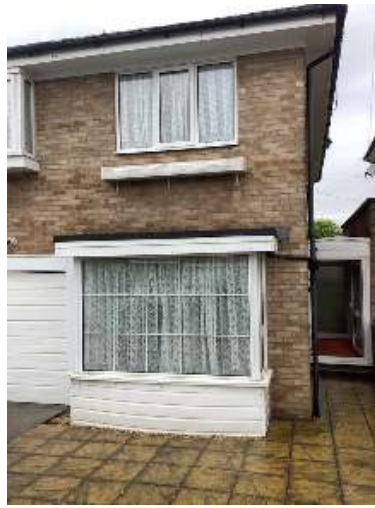
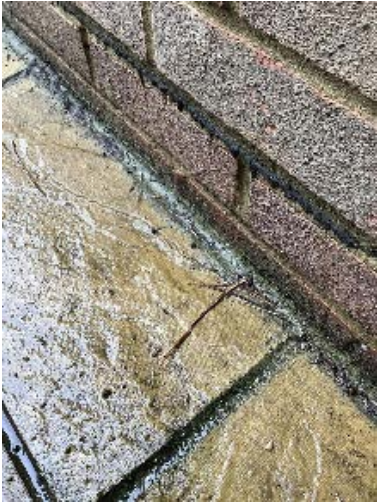
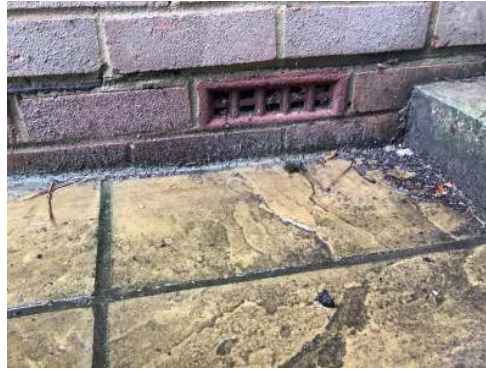
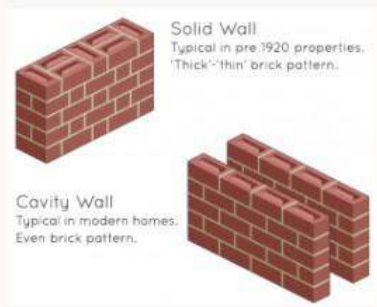
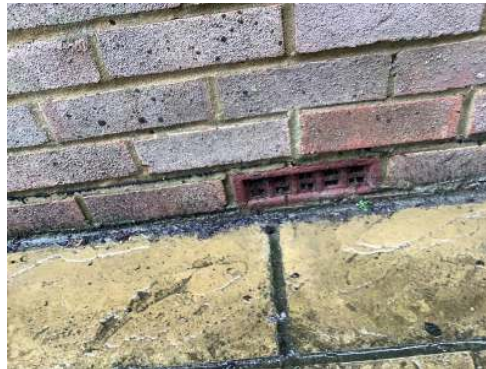
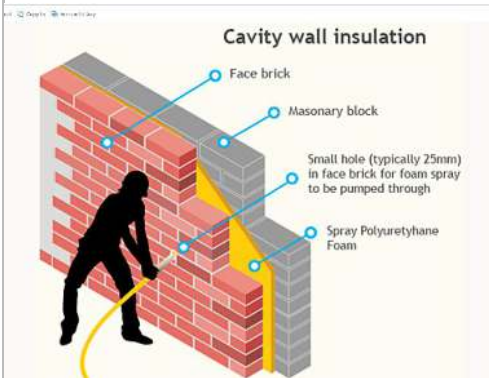
The property benefits from uPVC double glazed windows and frames throughout.

As mentioned earlier, the windows to the first floor bedrooms do not provide adequate means of escape and is therefore a health and safety hazard.

All first floor bedroom windows are not compliant with means of escape, we recommend these windows be replaced in the near future.

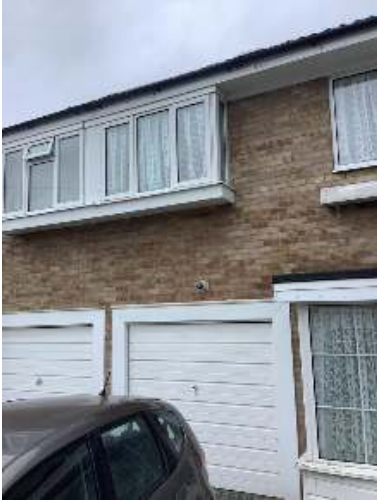
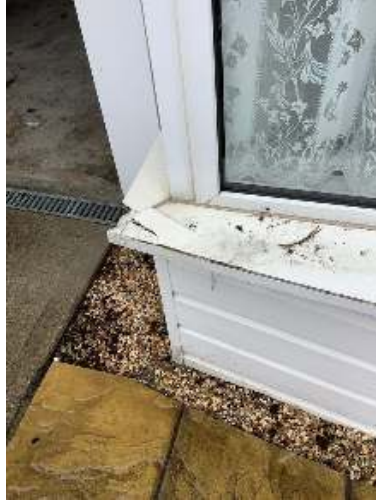
The property features glazed uPVC front and rear doors.

There are sealed glazed units set within the doors. Glazing in doors which is wholly or partially within 1500mm from floor level should be: Minimum Class C to BS 6206 and kite marked according to BS 6206. Glazing to the front and rear doors appeared toughened, however, there were no apparent markings to the glass. Markings may just be concealed within the framing, however, for full reassurance further investigations are recommended. If the glazing turns out not to be toughened, this will present a hazard to occupants.

Please consult your Legal Advisor in connection with FENSA certificates that might be available.

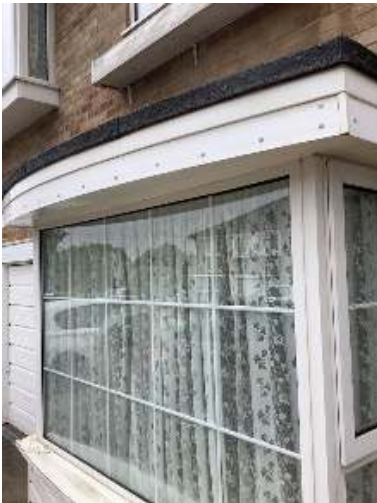
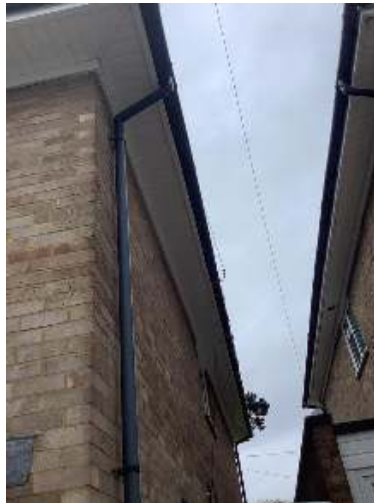
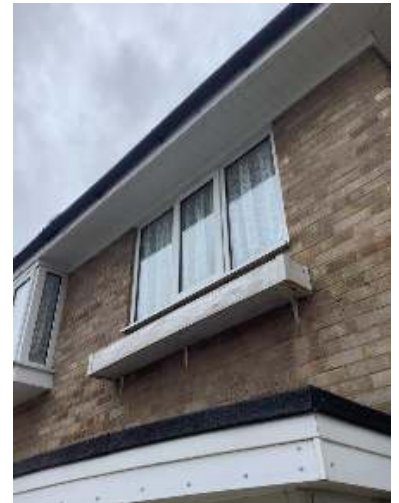
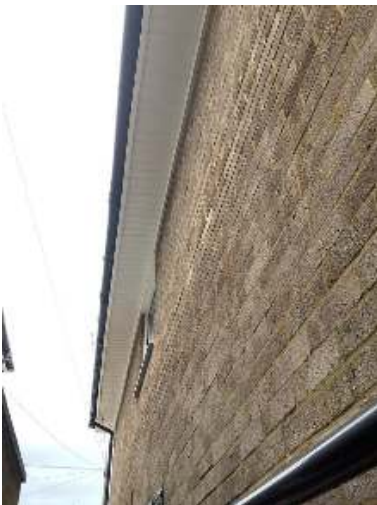
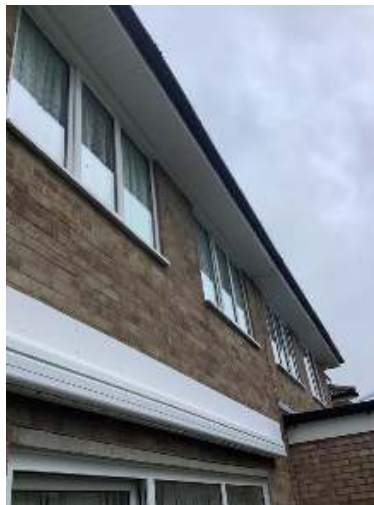
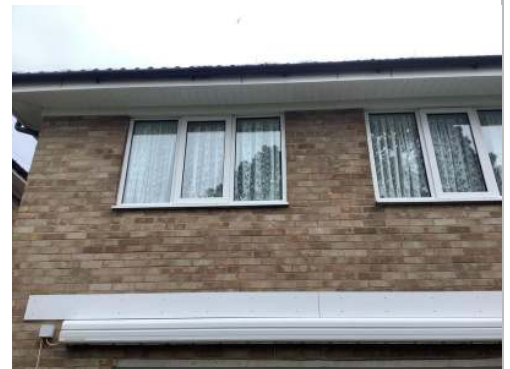
To safely repair/maintain parts of the property at higher levels, contractors will have to use appropriate access equipment (for example scaffolding, hydraulic platforms, etc.).

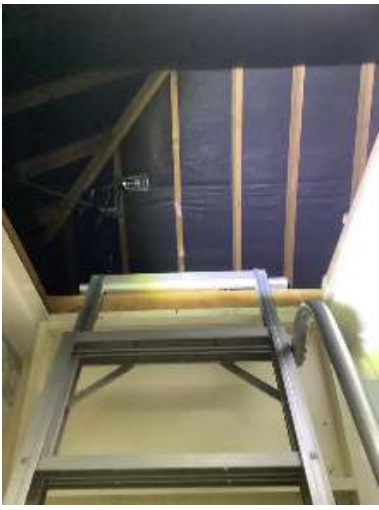
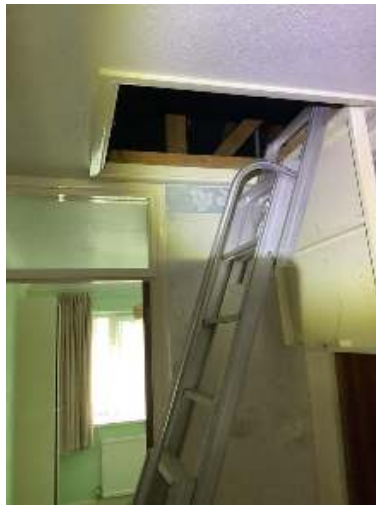
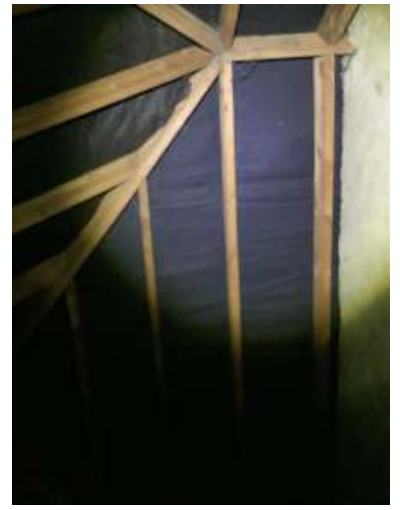
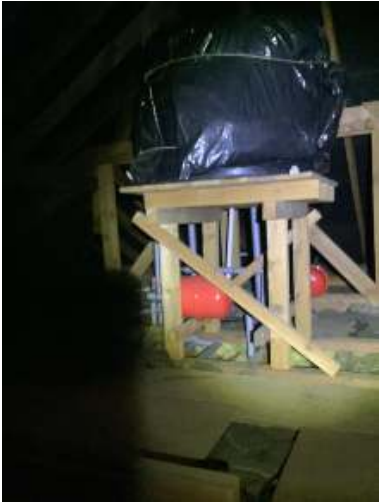
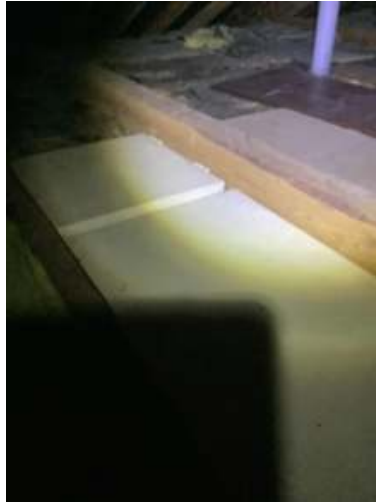
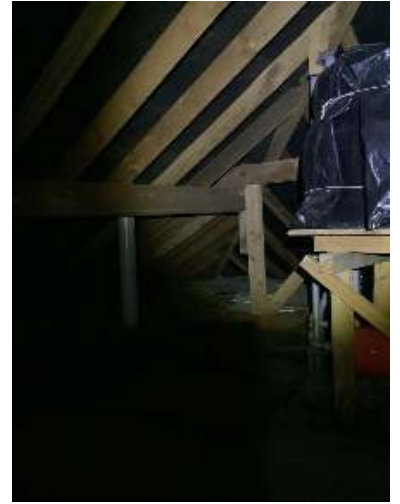
There is felt below the roof tiles. This appeared in satisfactory condition though is of a certain age. Roof felt acts as a secondary waterproofing layer in the event of slipped or defective roof tiles. All felt should be checked closely and any defects repaired as required. Tears or defects to roof felt can allow water ingress which can result in timber decay.

The first floor joists have been insulated with 100mm of quilted insulation. This has been compressed in areas by lofts boards. Current regulations state the desired thickness is 270mm upgrade is recommended. The party wall masonry and render visually appeared in acceptable condition at the time of my inspection. There where no apparent gaps or cracks to the party wall. The party wall should be inspected closely and any gaps should be infilled as required.

Ventilation of the loft space is essential to prevent the build up of potentially damaging condensation. Cold roofs should have some form of roof ventilation in place to prevent warm air condensing in the roof void. I recommend roof tile vents and soffit vents are installed to create two-way ventilation which will remove the damp air and creates gentle movement of air in the loft, helping to prevent damage to possessions or mould forming on the ceiling and timbers from rotting. Ventilation will help preserve the life of the roof structure and materials.

**Condition Rating - 2**

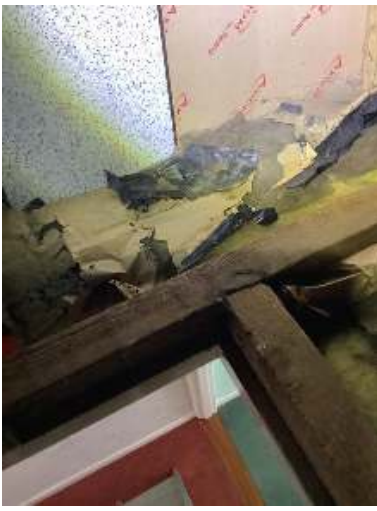
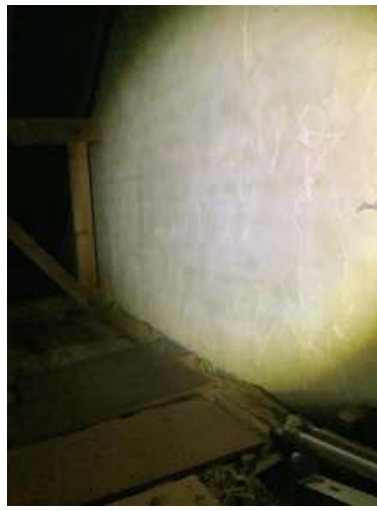
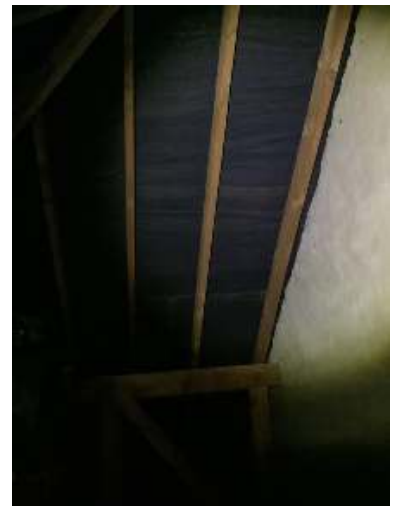
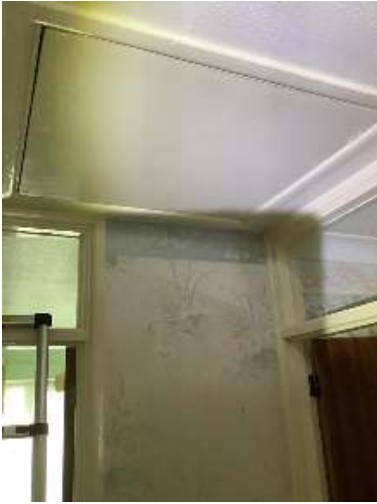
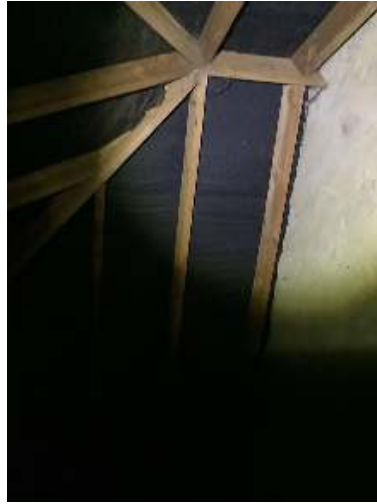
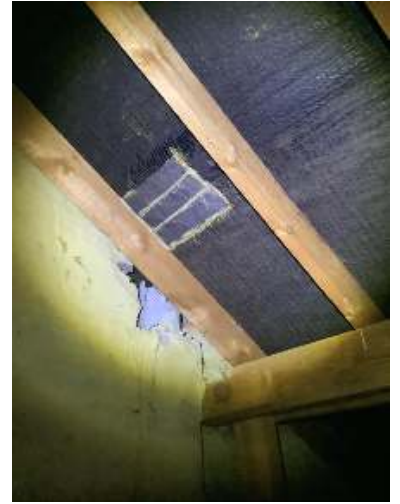
The ceilings to the property have been formed with plasterboard and finished with a textured coating all ceilings throughout have been coved.

Textured coatings were observed to ceilings. The below is provided for information should these ceilings be disturbed.

The sections of coving by the main entrance is polystyrene is deemed as a fire risk. We recommend these are replaced for plaster covings in due course. Condition rating 3.

The ceilings were in satisfactory condition with no defects of note. Hairline cracking noted in isolated areas is not structurally significant. Filling and redecoration is advised. Costs are not included.

The property has two battery powered smoke alarms fitted to the main entrance ceiling and landing ceiling the cover to the smoke alarm on the landing is missing. These were not tested.

**Condition Rating - 3**

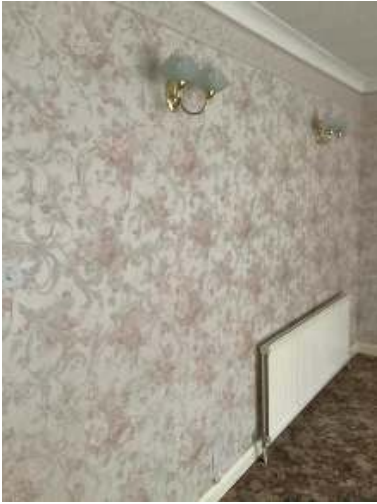
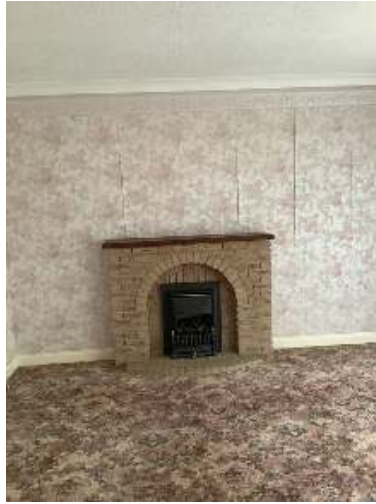
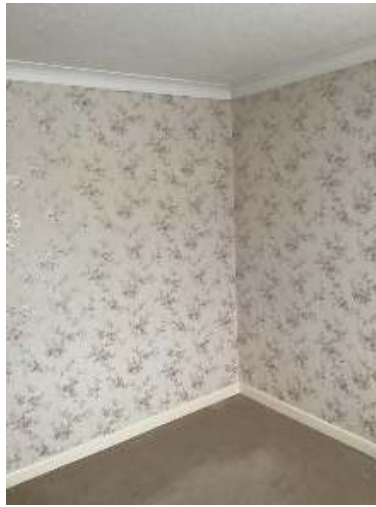
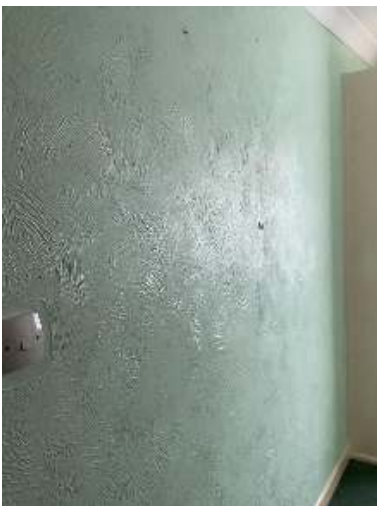
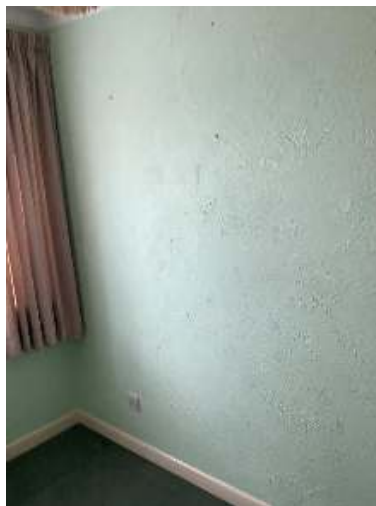
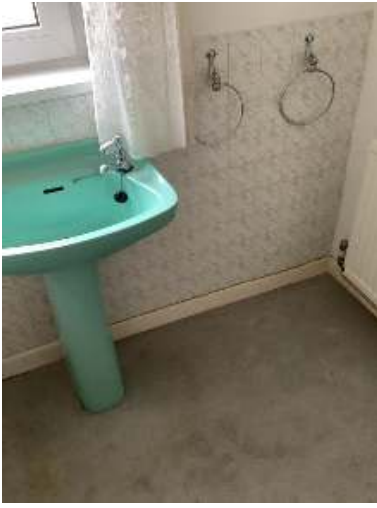
Ground floor and first floor to the property appear to be of suspended timber construction.

It was not possible to inspect sub ground floor timbers. Though there was no notable bounce, no dampness to walls and ventilation was adequate, it is recommended that sub floor timber joists be checked for any evidence of timber decay and damp and timber report instructed. A category 3 must be stated due to lack of inspection of sub floor timbers.

Minor creaking to suspended timber floors was noted.

All finished floors to property have been carpeted though out all carpet appeared in condition though dated.

**Condition Rating - 3**

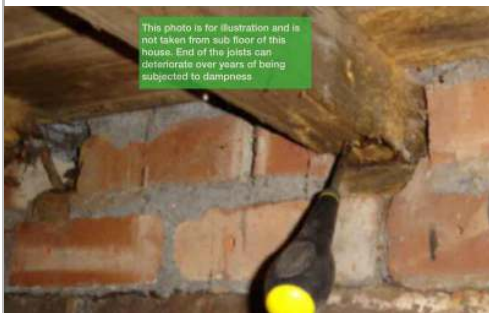
This photo is for illustration and is not taken from sub floor of this house. End of the joists can deteriorate over years of being subjected to dampness

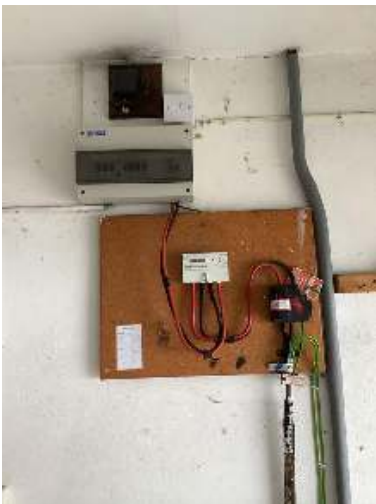
The consumer board is fitted with circuit breakers. It appears to be in satisfactory condition however, it is recommended that at any change of ownership the electrical wiring should be checked by an NICEIC qualified electrician.

There was no current electrical certification confirming the condition of the electrics within the property.

In the absence of a current test certificate we must designate a level three risk. If certification is available, please ask your legal advisor to check the validity of this evidence.

**Condition Rating - 3**

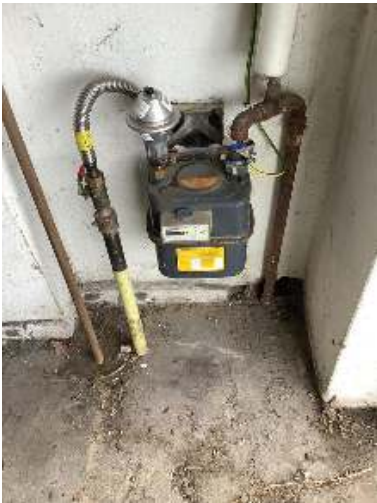
The gas meter is located inside the garage and appeared in satisfactory condition.

In the absence of a current test certificate we must designate a level three risk. If certification is available, please ask your legal advisor to check the validity of this evidence.

**Condition Rating - 3**

I would recommend that at the change of ownership the gas meter is checked to ensure that the gas is safe to use.

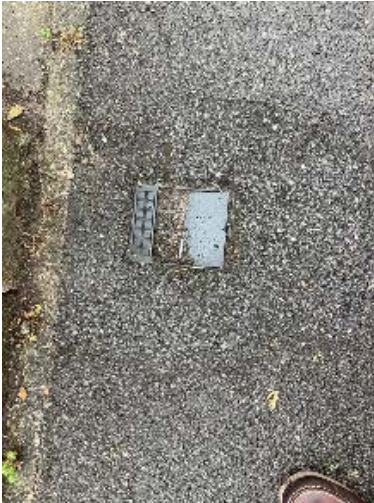
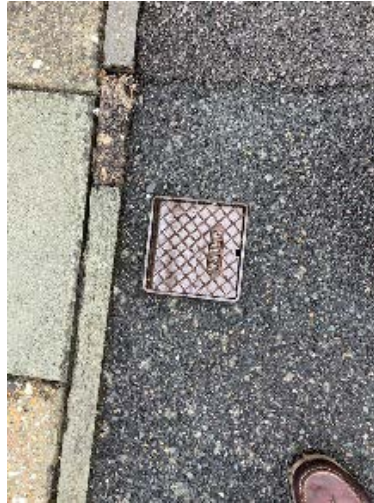
The water supply comes from the water company. Taps were tested and there appears to be adequate water pressure at the time of inspection. As part of ongoing maintenance, taps should be regularly checked for leaks.

I am unable to locate the internal stop tap however there is a main stop tap out in the pavement. The mains incoming pipe could not be observed.

### Condition Rating - 3

I would recommend that the mains pipe is identified to establish whether an upgrade is required. Bringing a new supply into the house could be expensive depending on where the main supply is. If this were to be required, there are certain regulations that apply. Please see the Water Regulations 1999 which detail the methodology if a new mains is required.

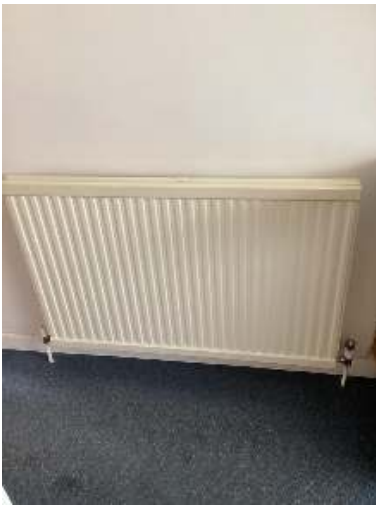
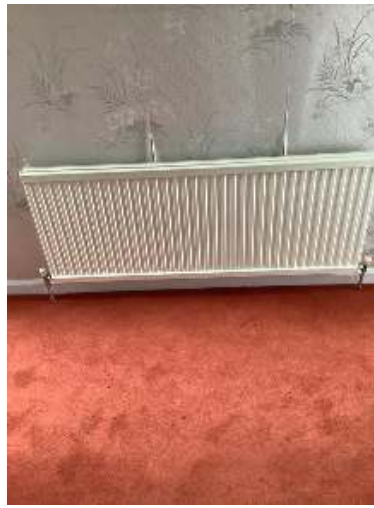
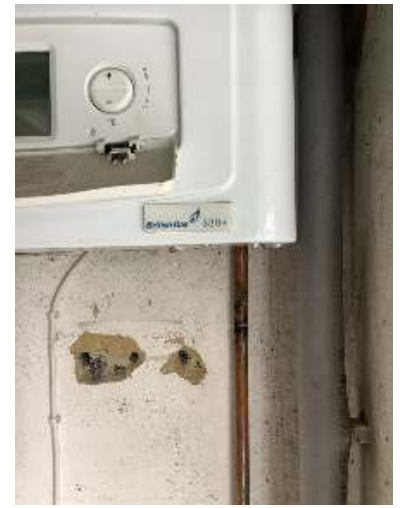
The gas fired boiler is located in the garage.

The boiler appeared in satisfactory condition though was not tested.

Pressed steel radiators appeared in satisfactory condition with no evidence of leaks.

In the absence of a current test certificate we must designate a level three risk. If certification is available, please ask your legal advisor to check the validity of this evidence.

**Condition Rating - 3**

We recommend that a test of the installation to be undertaken prior to purchase and that regular maintenance contract be placed with an approved heating engineer.

We recommend that the service record of the boiler is obtained and if this not available, or if there is any doubt as to when the boiler was last serviced, then a check by a Gas Safe registered heating engineer before exchange of contracts is strongly recommended.

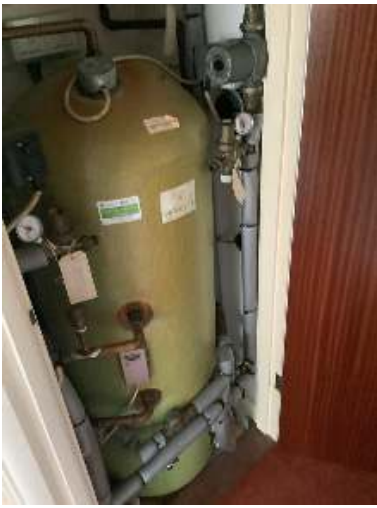
## F5 Water Heating

Domestic hot water is provided by factory-lagged copper hot water cylinder located in the airing cupboard in the landing. The cylinder appeared to be in satisfactory condition, and the factory lagging will give good protection against heat loss.

In the absence of a current test certificate we must designate a level three risk. If certification is available, please ask your legal advisor to check the validity of this evidence.

**Condition Rating - 3**

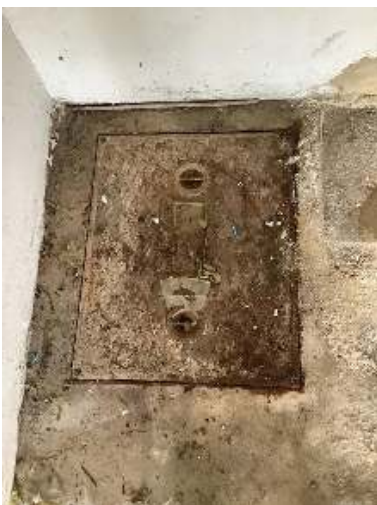
## F6 Drainage

Whilst there were no apparent defects which could be attributed to underground drainage defects, it would be prudent to instruct a CCTV drainage survey to check for any issues.

We have not checked to see if that is a separate system or a combined system of drainage operating. However, it is likely that the drainage system is a combined system.

**Condition Rating - 3**

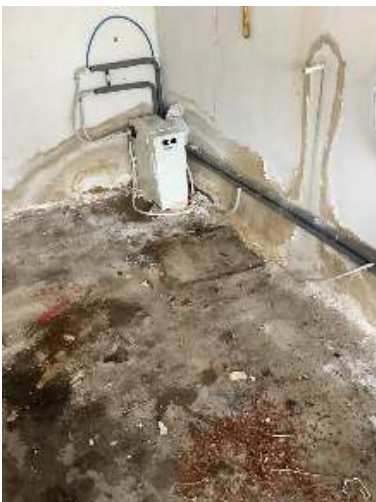
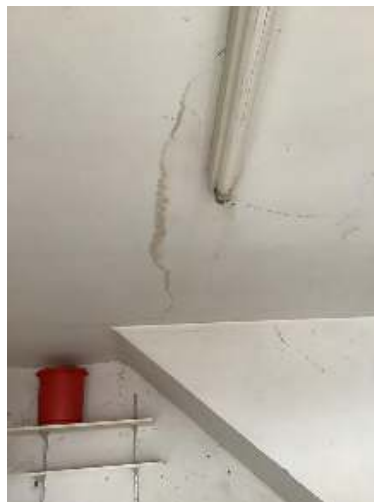
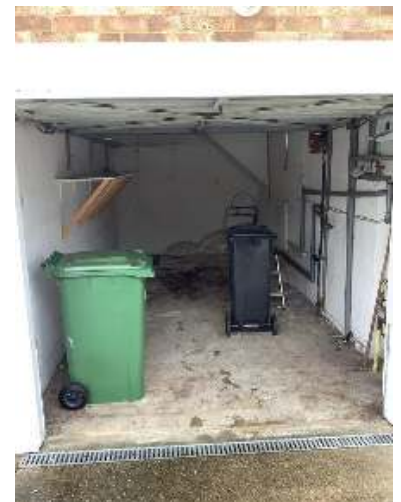
The property features an internal garage with an metal up and over door with timber frame. The walls to garage have visible signs of staining this will require further investigation. Overall the garage appeared in fair condition.

Integral garages should be suitably fire rated to reduce the risk of fire spread to habitable areas. The walls and ceiling appeared to be of suitable fire rated construction however, intrusive investigations would be required to confirm.

Condition Rating - 2
